**Project:** Polynesian Cultural Center

## The Polynesian Cultural Center

### *Preserving Historical Integrity*

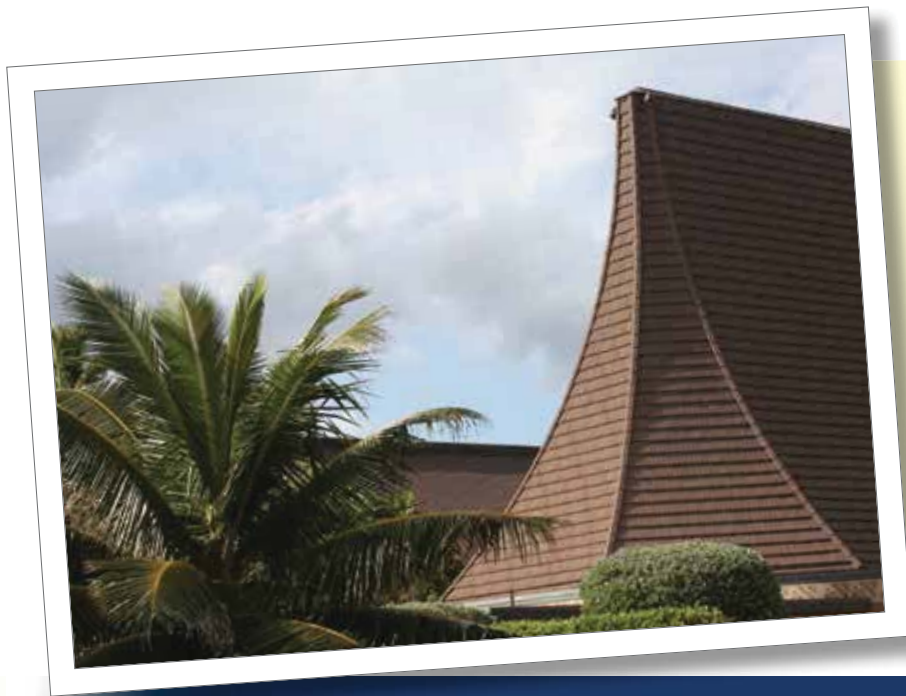
**Challenge(s):** Replace the thatch roof while maintaining the cultural and historical integrity of the Center.

**Solution:** DECRA Shake's pattern and texture emulates the original thatch.

**Profile:** DECRA Shake

In this situation, battens and counter battens were used over the skipped/spaced sheathing without fill. While there is no replacement for original thatch, the DECRA Shake was a great alternative for the Center; the stamped shake pattern on

the steel resembled the random look of the thatched roof. The ceramic stone granules that protect the steel panel also provide texture so the roof does not appear flat, further emulating the original thatch and maintaining the cultural and historical integrity of the Center.
